SESSION 3

Inspection and Maintenance of Dams and Spillways

Inspection of a dam

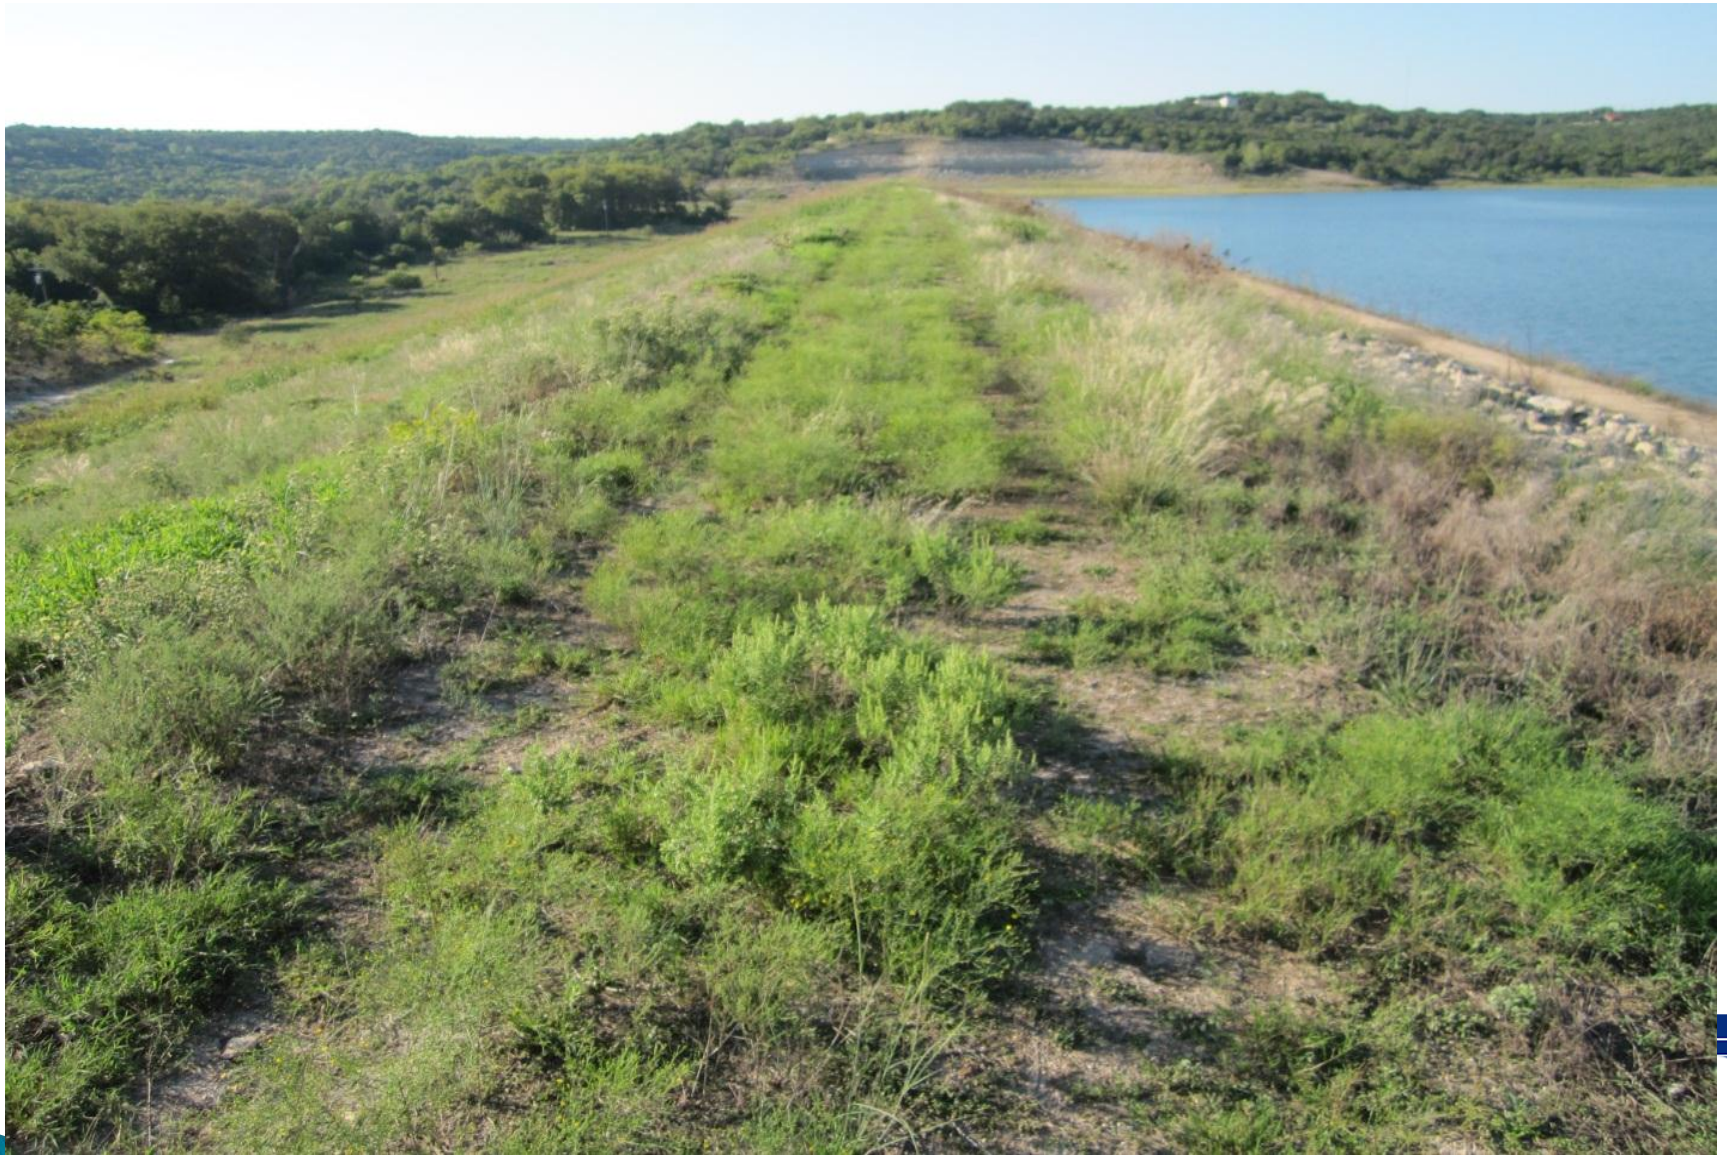
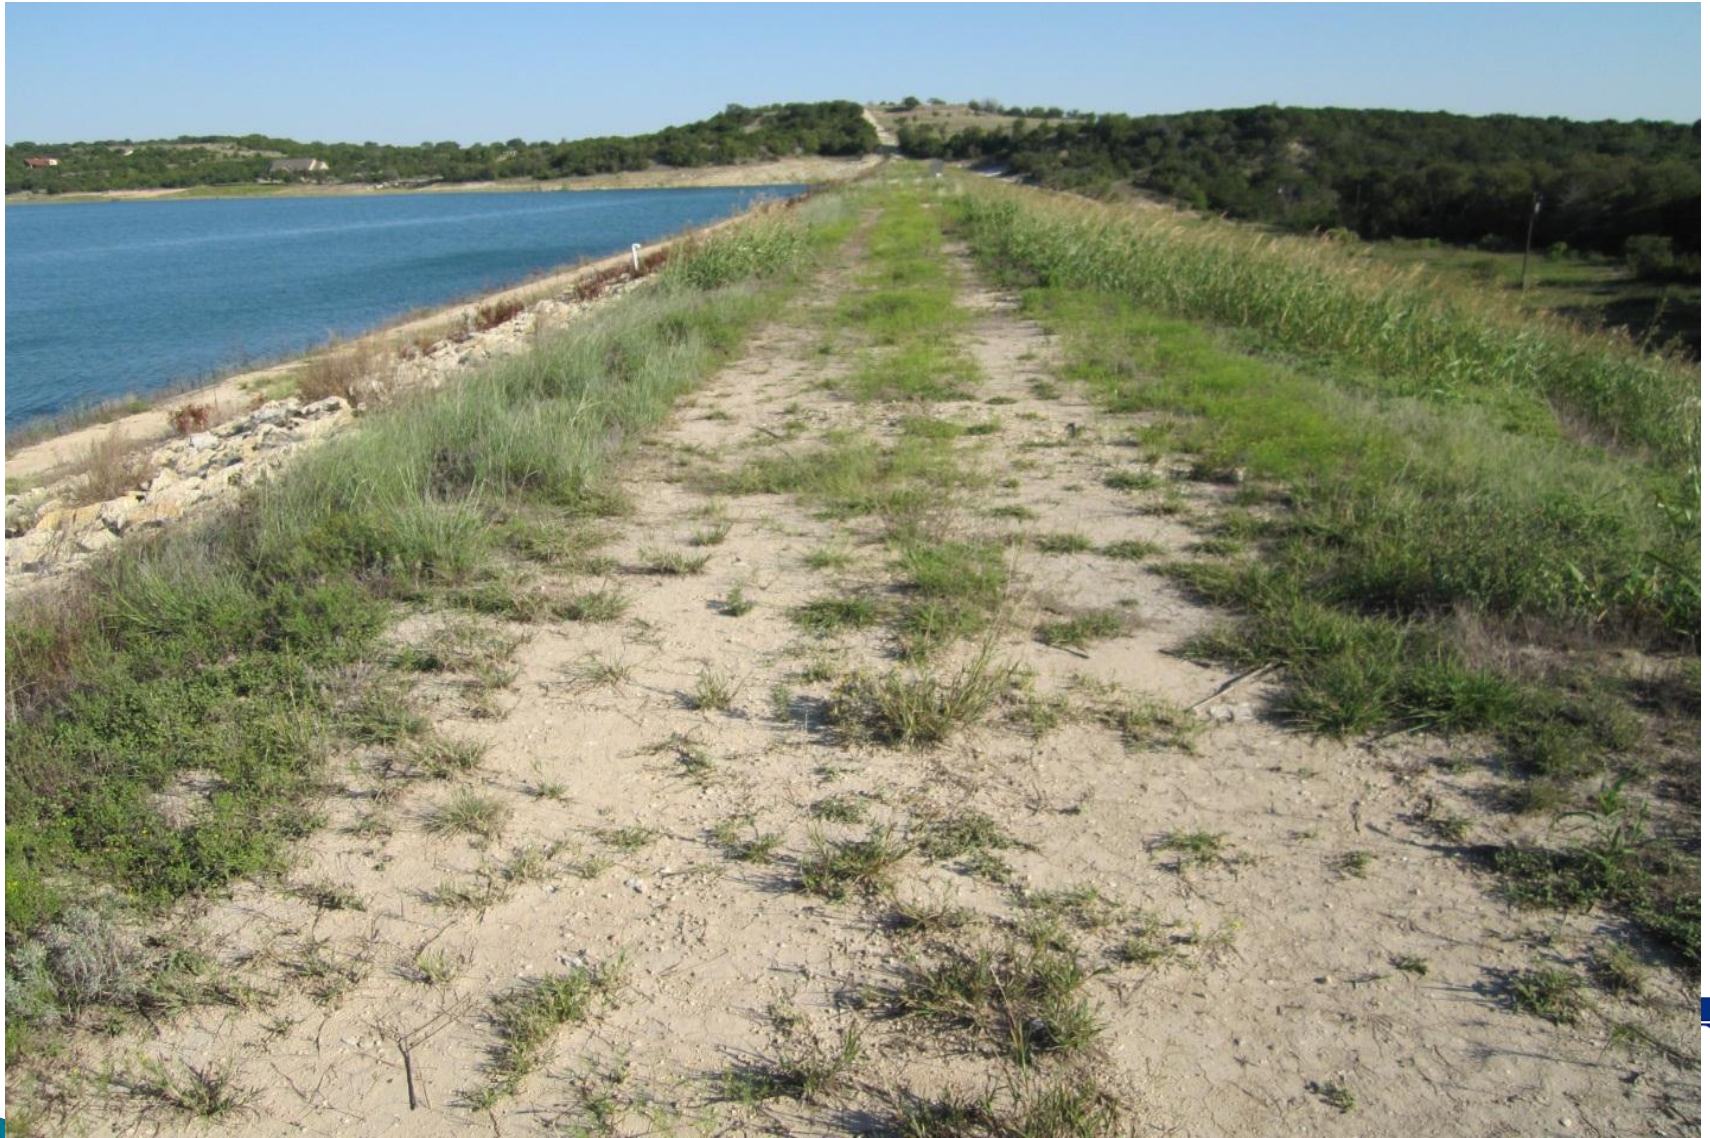
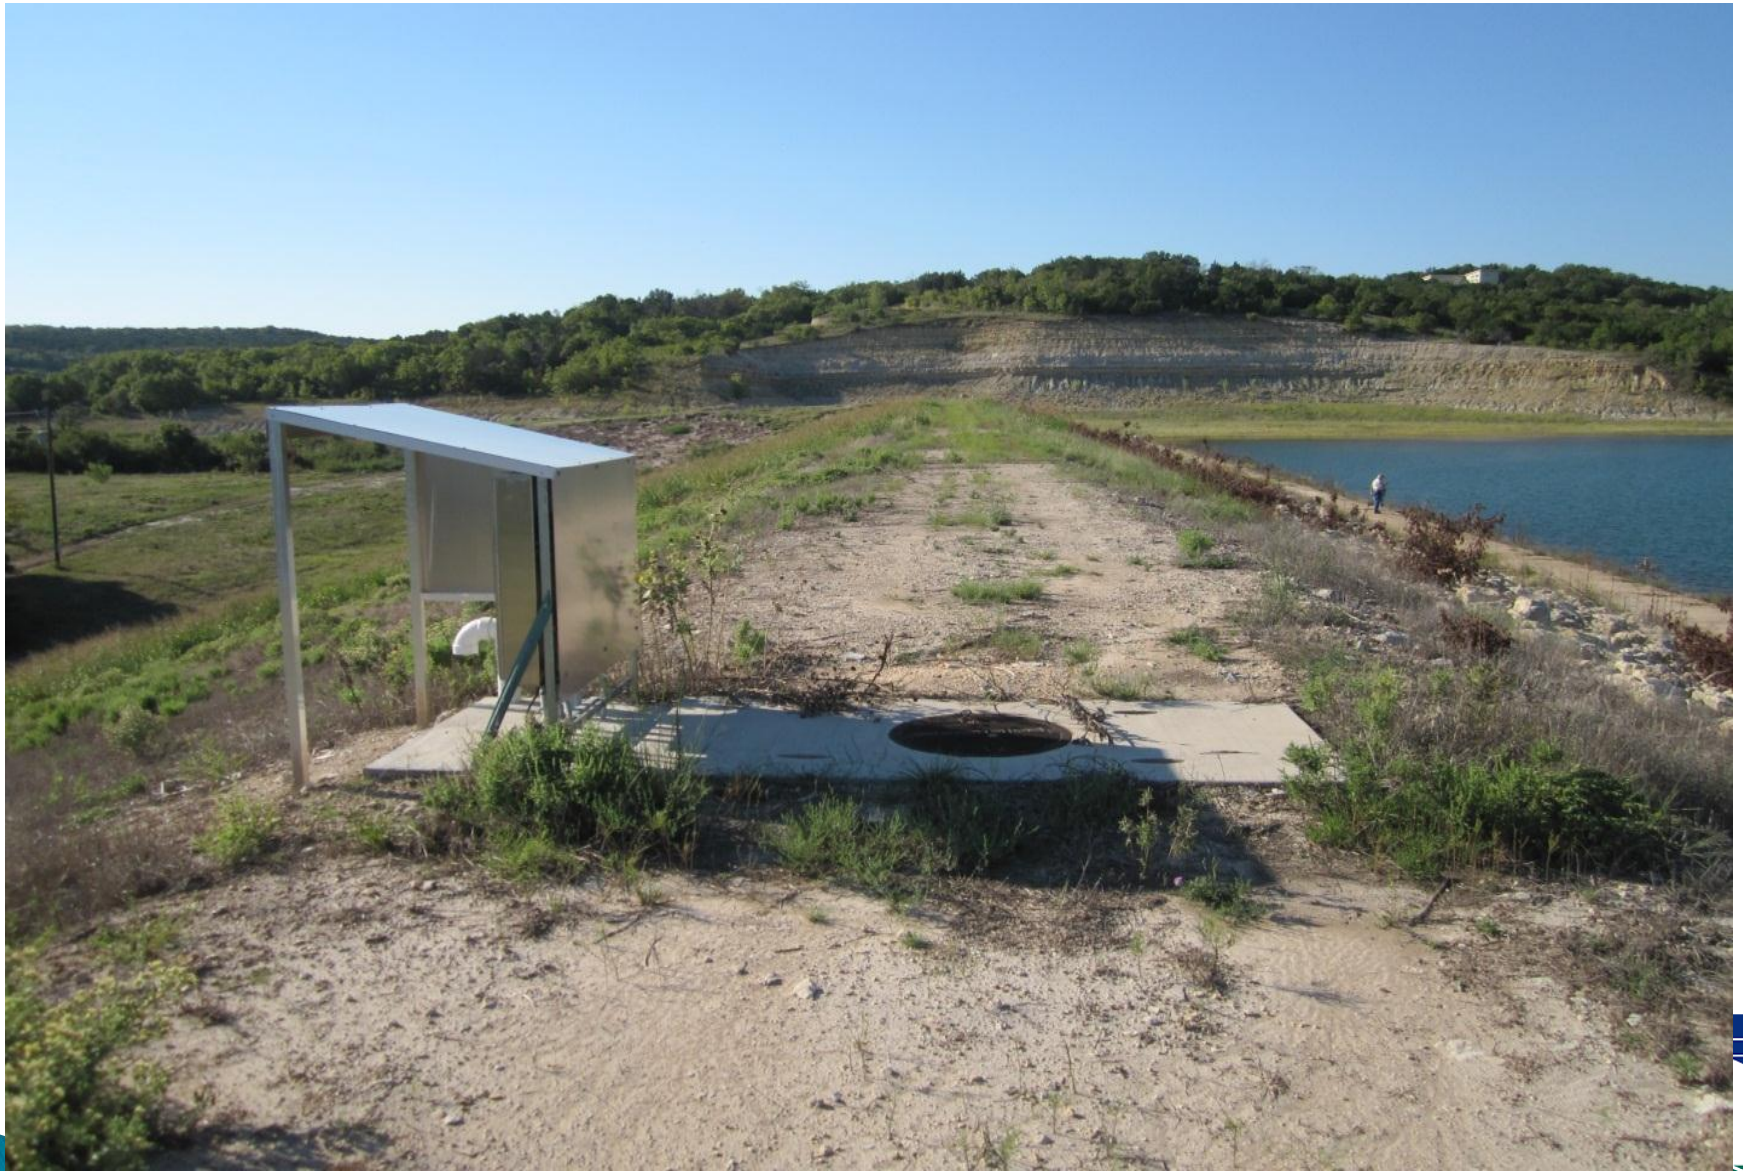
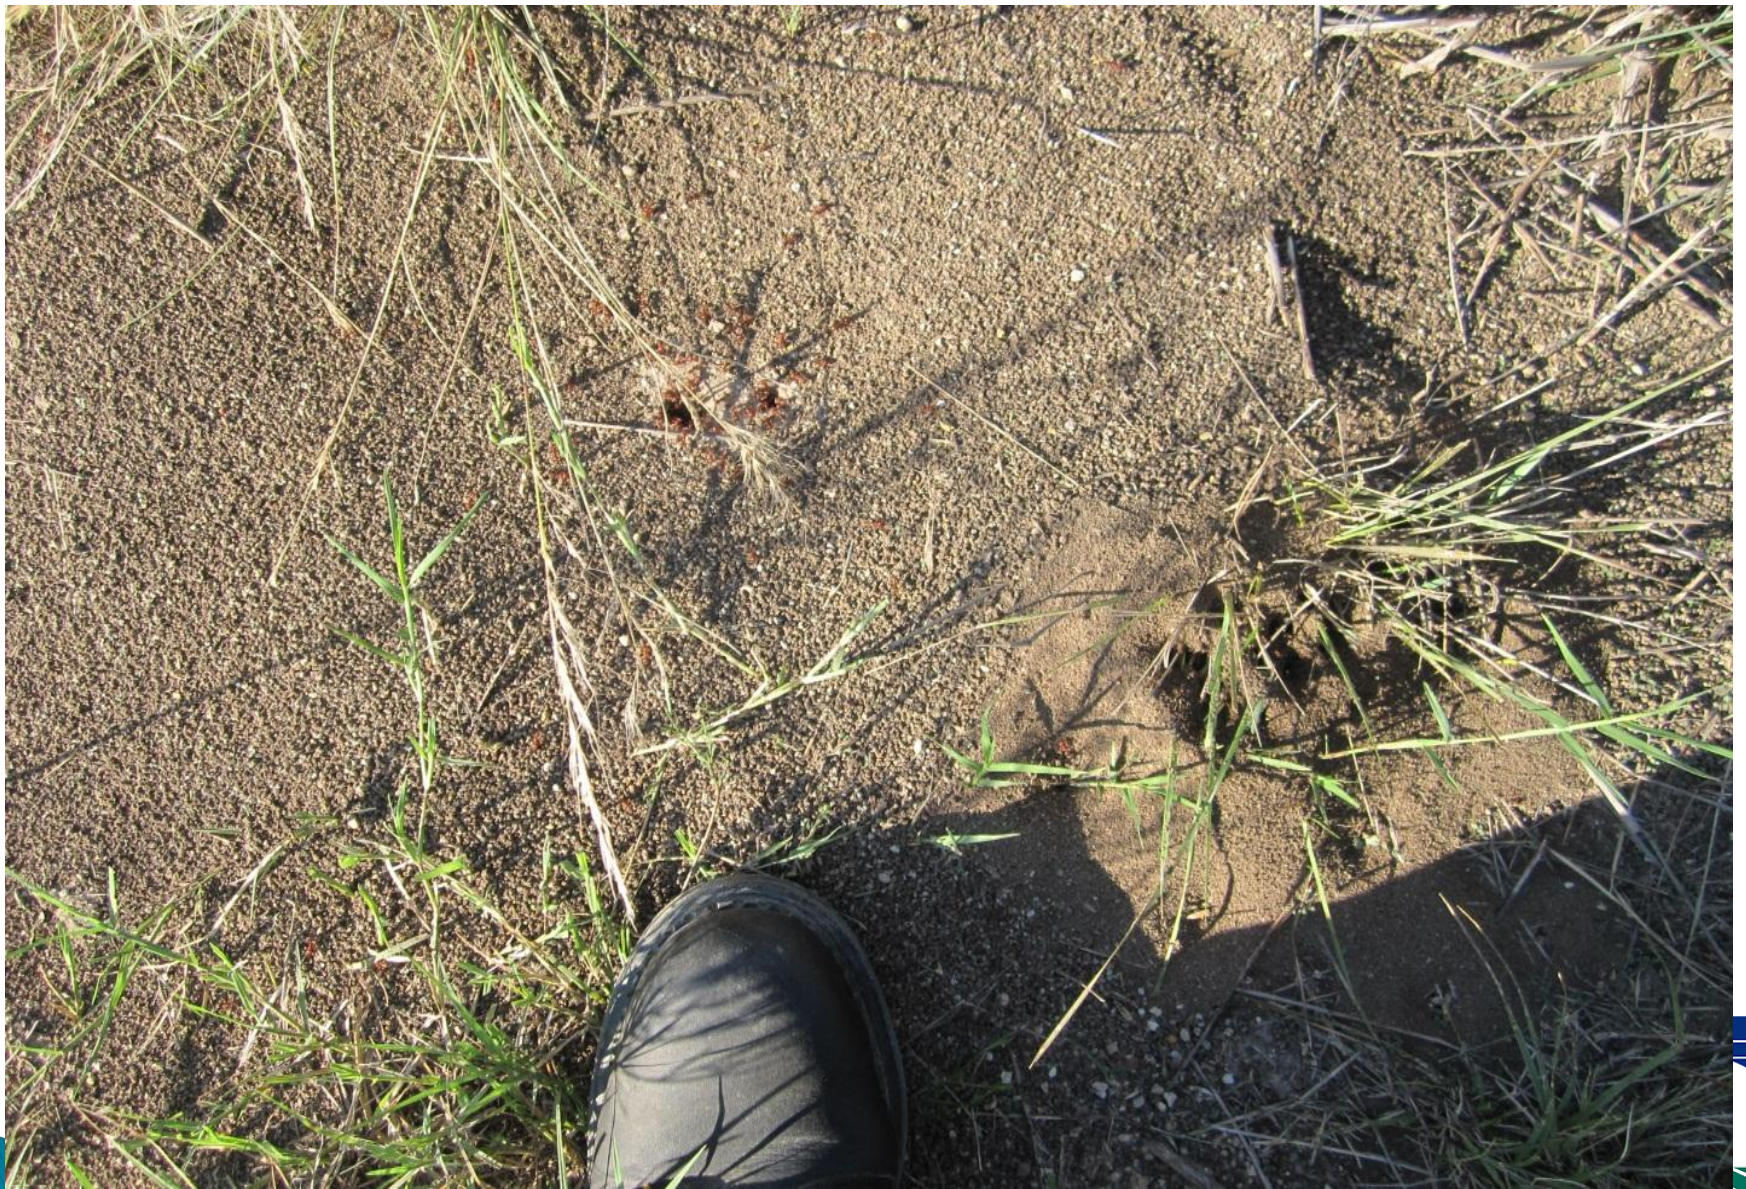
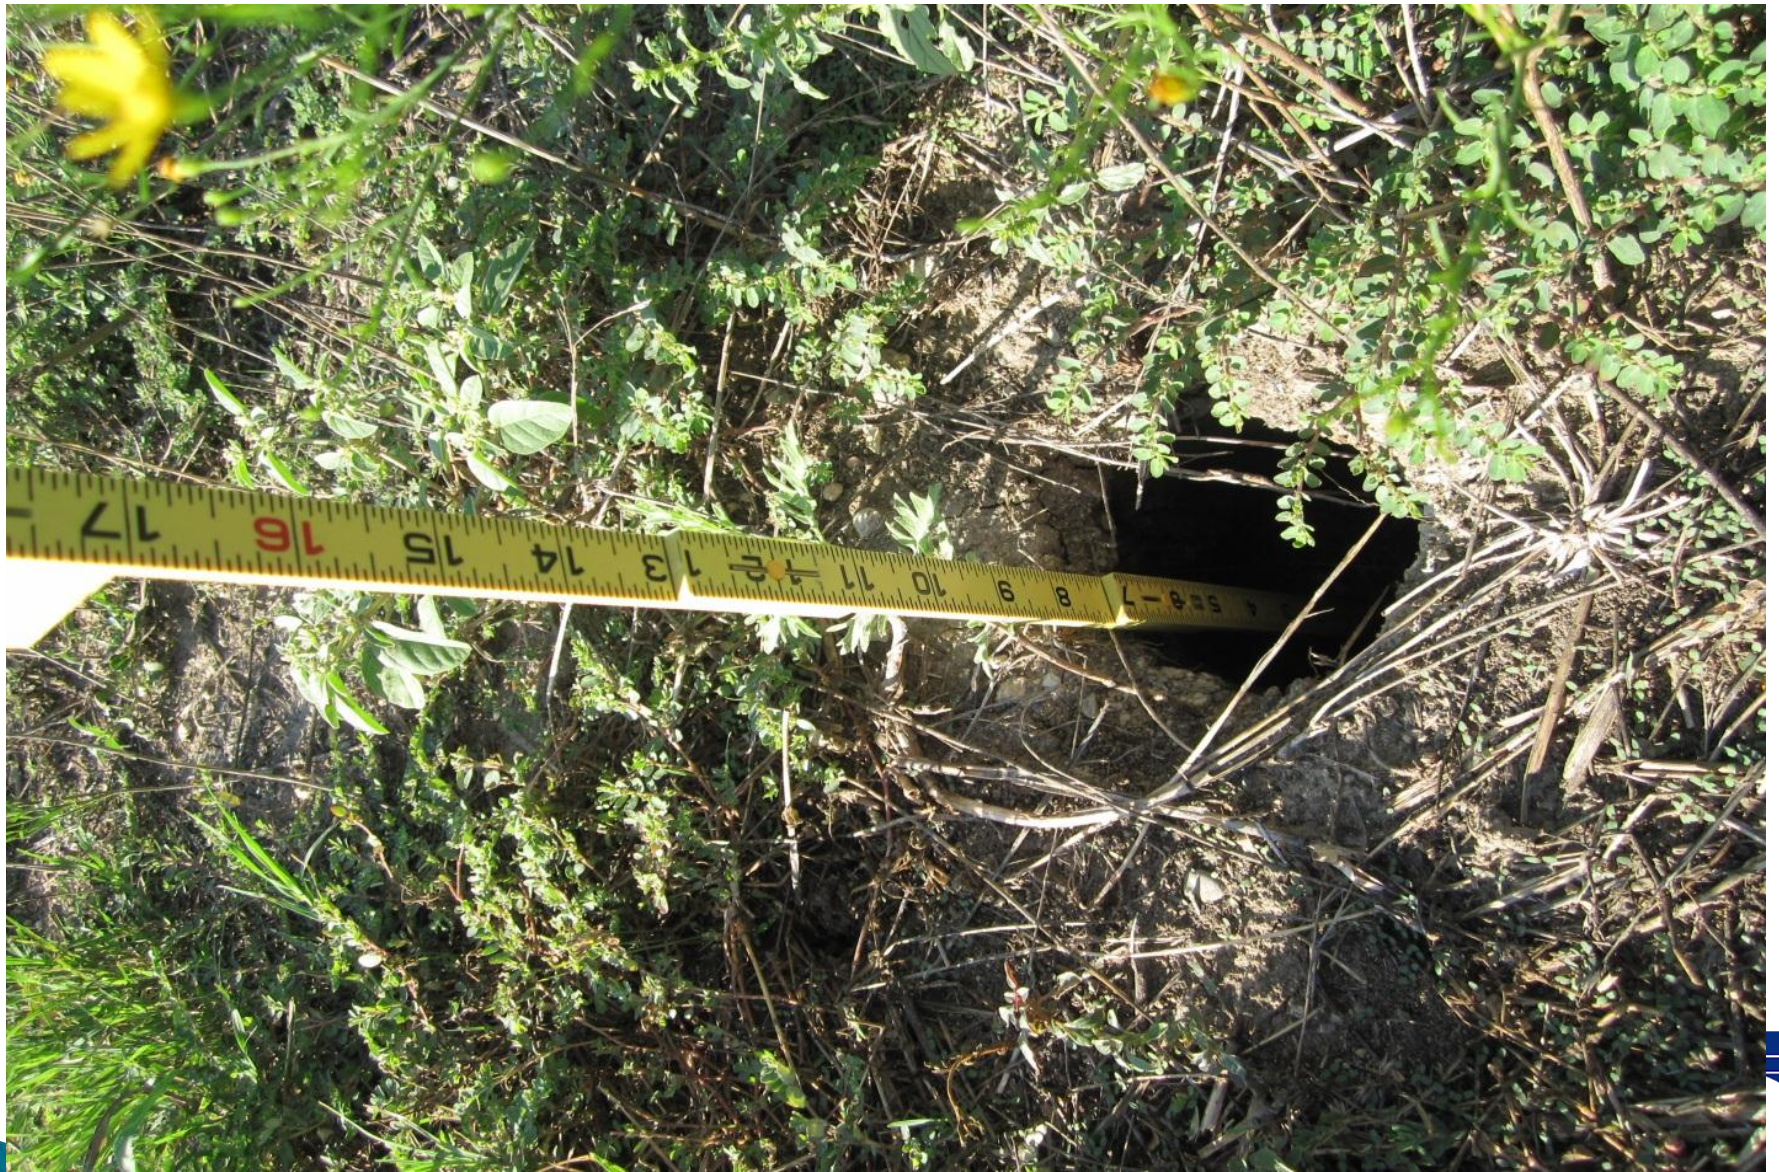
Crest of the dam

- ▶ Sparse grass cover with bare areas
- ▶ Grass cover needing mowing
- ▶ An ant mound
- ▶ Hole in the crest

- ▶ Re-establish a grass cover, if at all possible. Drought is preventing, or hurting, development or maintaining a grass cover
- ▶ The grass needs to be mowed on a regular scheduled basis (three times a year preferred)

- ▶ The hole noted in the crest should be filled.
- ▶ The ant mounds should be poisoned to prevent the ants from causing problems with the dam. Pay special attention for ants around the electrical panel on the crest of the dam.

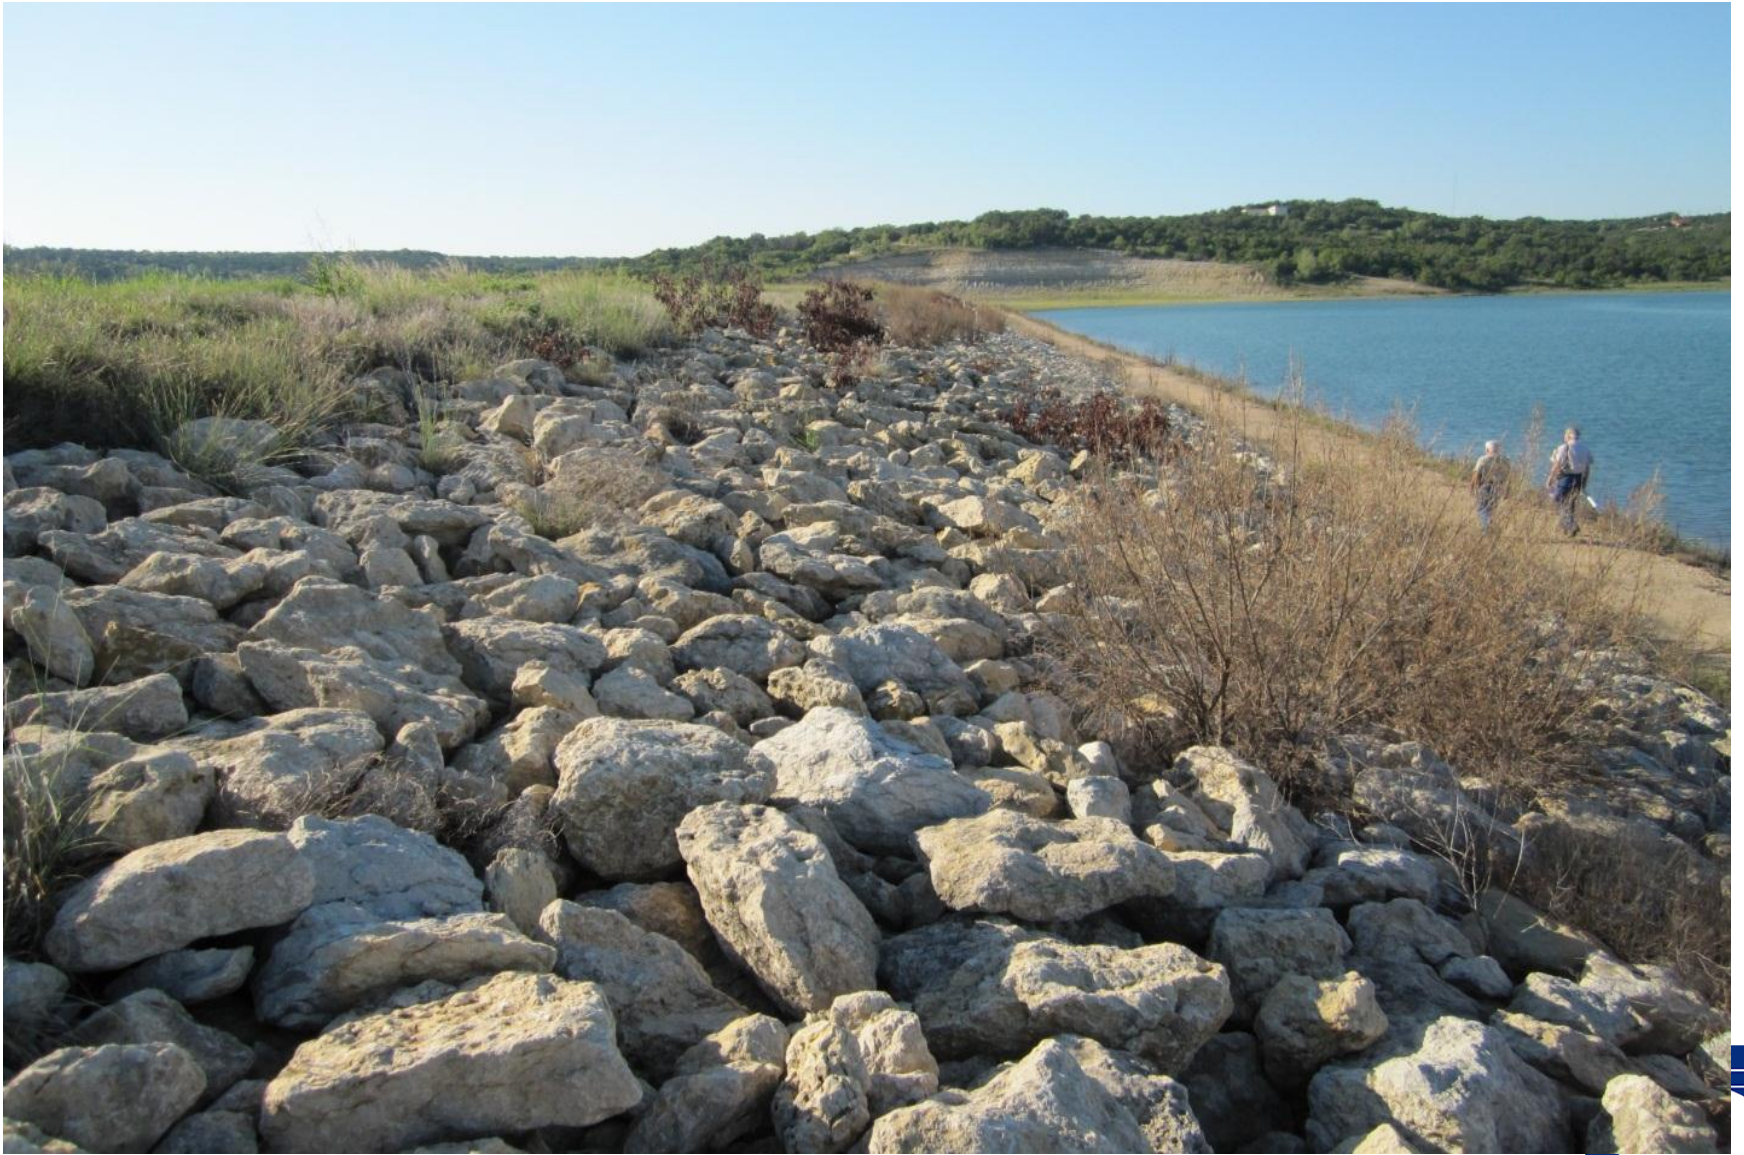
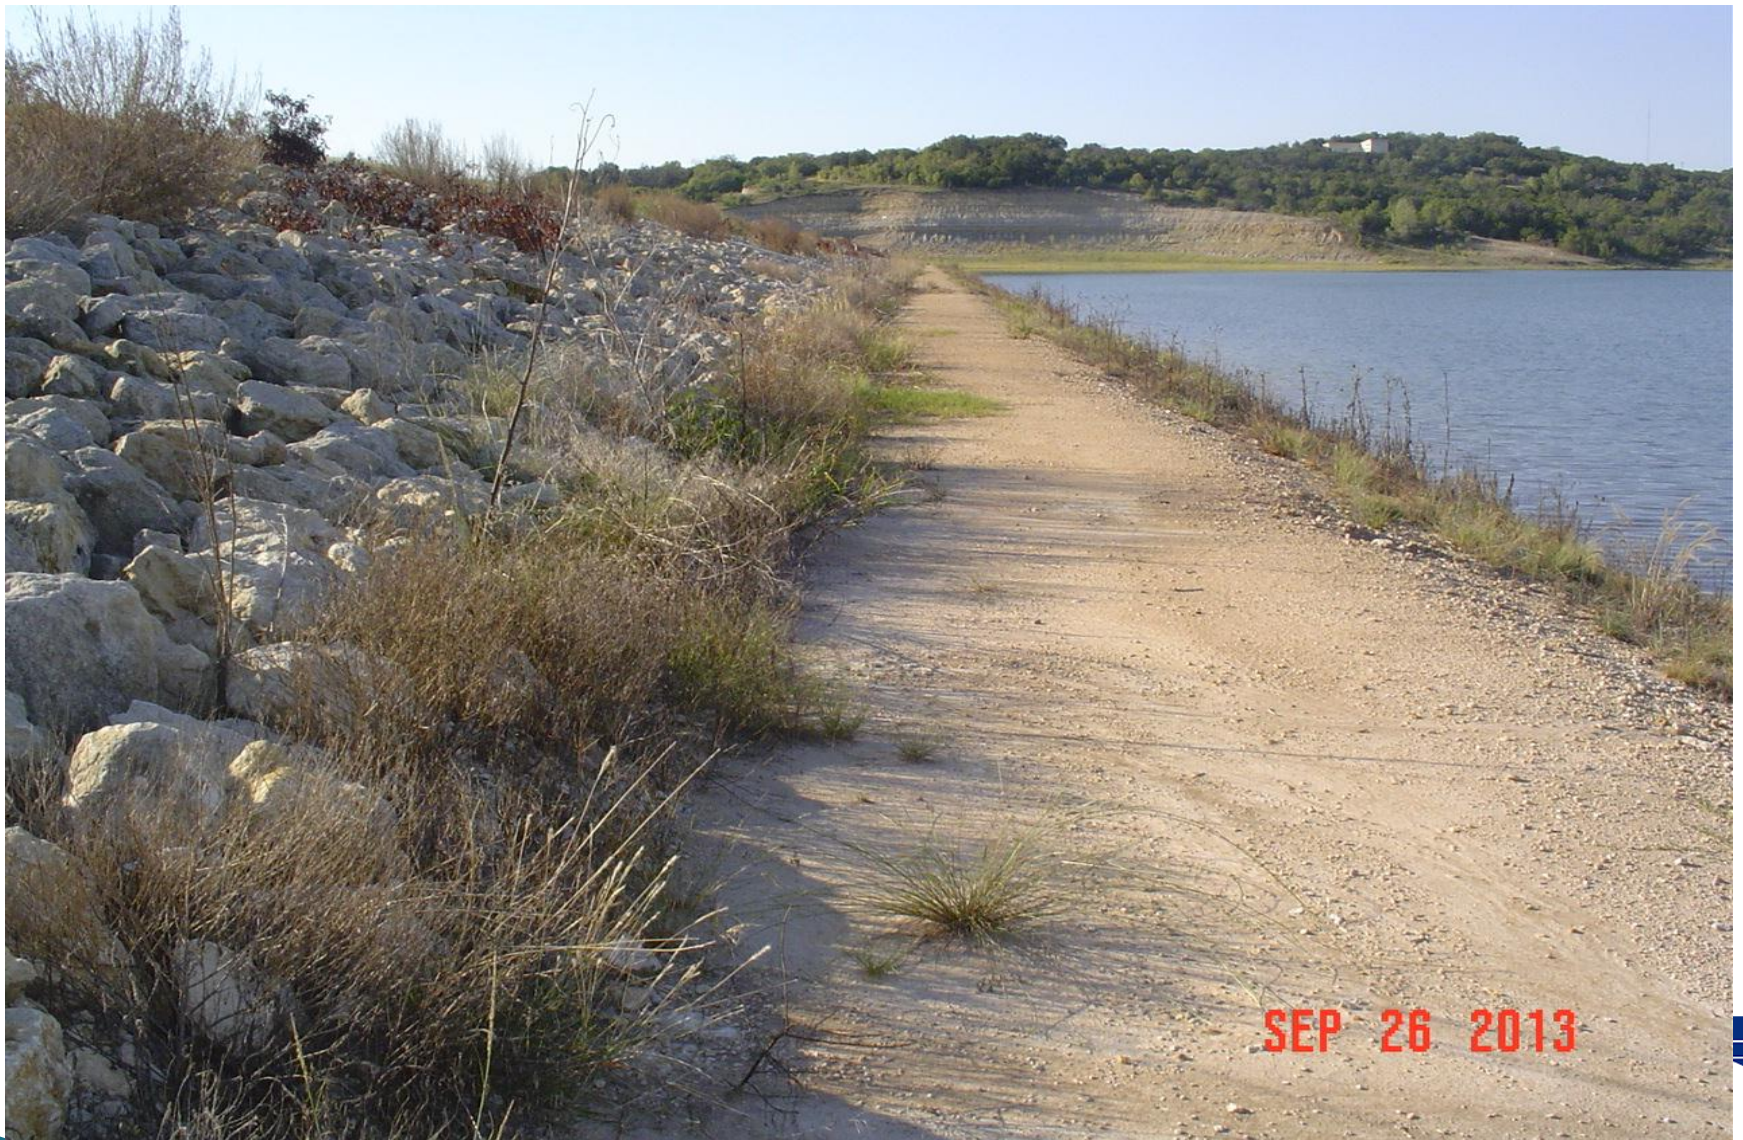
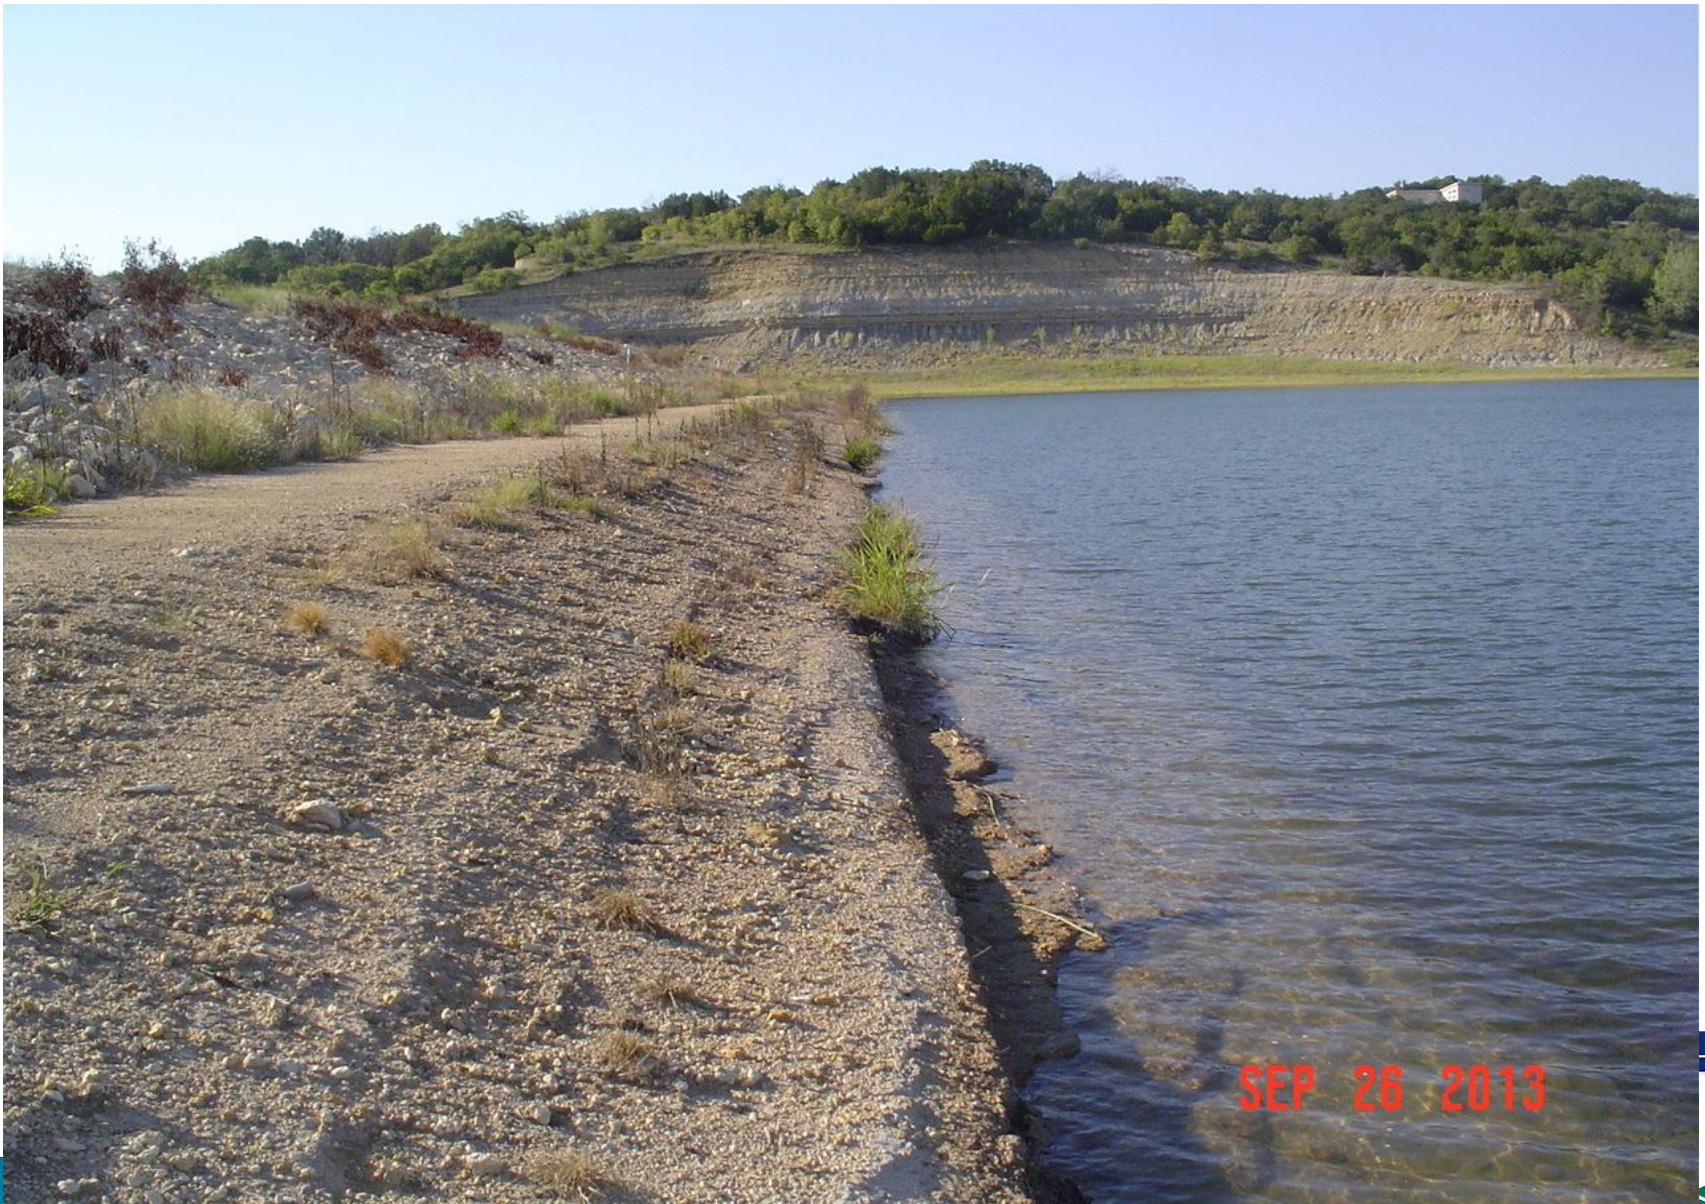
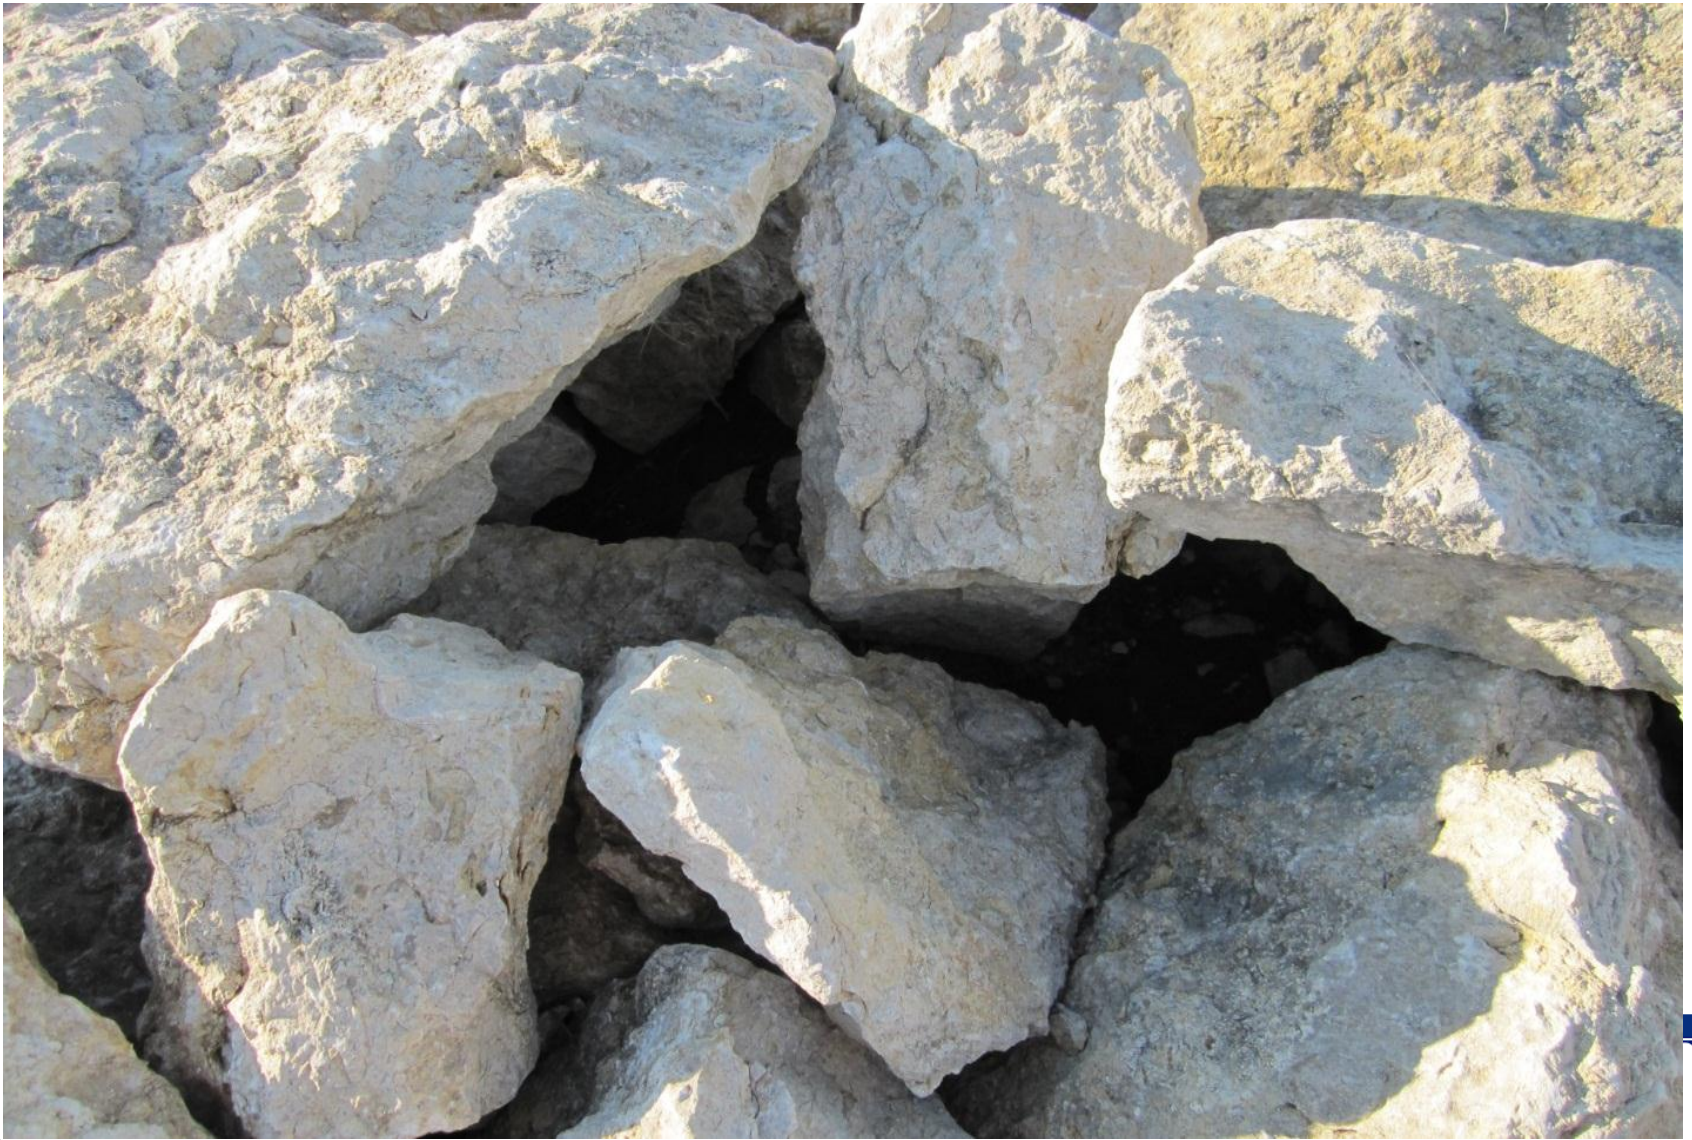
Upstream slope of the dam

- ▶ Small trees in riprap
- ▶ Holes in riprap coverage
- ▶ Wave action erosion along water line

- ▶ The trees on the slopes of the dam should be removed. Some of the trees had been poisoned, while others had not. A periodic removal or spraying schedule should be established and followed.
- ▶ As the lake level rises, the rock riprap should be monitored for movement. The monitoring may need to be done by boat. If wave action results in movement of the rock, a process should be established for replacement of the rock.

- We made no recommendation on the wave action erosion since the lake was continuing to rise. Normally, we recommend:
 - Reestablishing slope protection including bedding material. An engineer may be required to design the slope material.
 - Flattening the slope before replacement of the slope protection.
